Manhole Inspection Summary

Manhole # S09QQ1029MH

Insp Date: **1/21/09 12:44 PM**

Location Address: **5115 PARK HEIGHTS AVE**

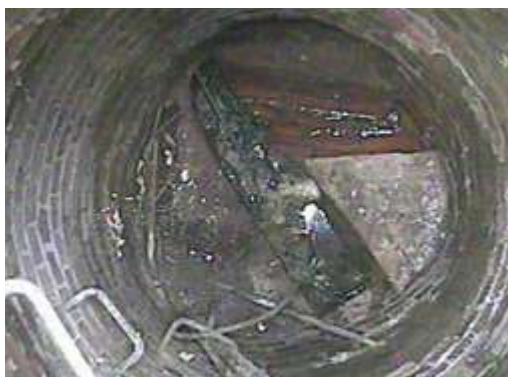
Defect 1

Condition: ☐ Sound ☐ Cracked ☐ Root Intrusion ☐ Deteriorated ☐ Leaks ☒ **Debris**

DEBRIS ON BENCH

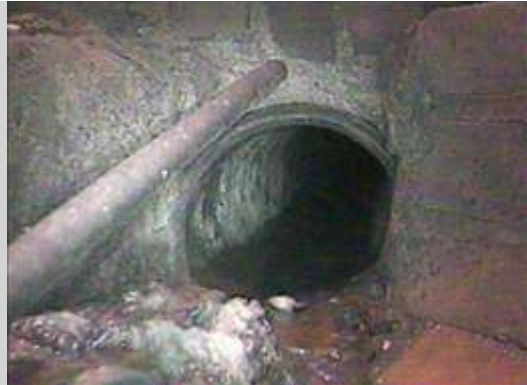
12 O'Clock Outflow

8 in. Circular Gravity Sewer
Pipe Out @ 12 O'Clock

Pipe Height: (in.) Direct
Pipe Material: **Clay** ☐ Pipe Lined
Invert Depth: **8.57** (ft.) Flow Characteristics: **Slow**
Deposits: ☐ None ☐ Mud ☐ Sludge ☒ **Debris** ☐ Grease
Silt Depth: **0.5** (in.) Deposits Extent: **Light**
Infiltration: **None** Pipe Seal Cond: **Sound**

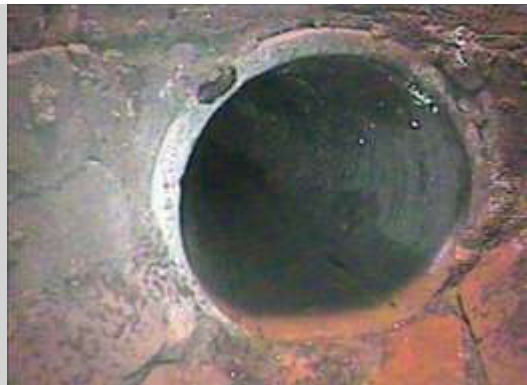
3 O'Clock Inflow

8 in. Circular Gravity Sewer
Pipe In @ 3 O'Clock

Pipe Height: (in.) Direct
Pipe Material: **Clay** ☐ Pipe Lined
Invert Depth: **8.34** (ft.) Flow Characteristics: **Slow**
Deposits: ☒ **None** ☐ Mud ☐ Sludge ☐ Debris ☐ Grease
Silt Depth: (in.) Deposits Extent:
Infiltration: **None** Pipe Seal Cond: **Sound**

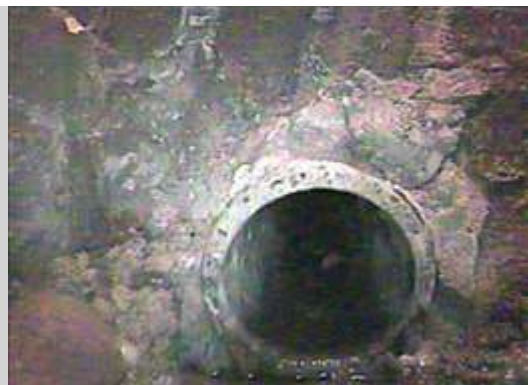
6 O'Clock Inflow

6 in. Circular Gravity Sewer
Pipe In @ 6 O'Clock

Deposits: ☒ None ☐ Mud ☐ Sludge ☐ Debris ☐ Grease

Pipe Seal Cond: **Sound**
